Maintenance & Repair Committee Meeting

Monday, September 11, 2023

Damage Prevention Outreach Program Task Force

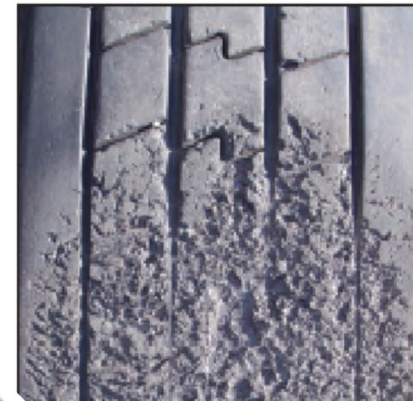
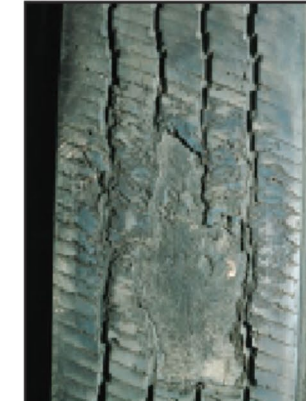
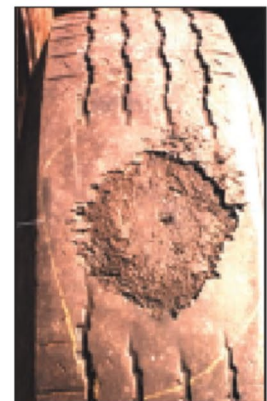
BRAKE SKID

Localized spot of excessive wear across the tread face that may extend into the casing. Surface texture may show circumferential abrasion marks from tread sliding on pavement, but surface may have since worn smooth. Usually exhibited on both tires in a dual assembly.

Aggravated by: new brakes (high-friction, not worn-in), malfunctioning and/or unbalanced brake system, aggressive use of brakes, frozen brakes, driver abuse such as the use of only trailer brakes to stop a vehicle, and unloaded vehicles. (Continued below.)

If all trailer tires exhibit brake skids, there is a high probability that the conditions were the result of driver abuse and/or aggressive use of brakes. However, they may also be caused by a catastrophic loss of the supply line air pressure or moving this equipment before the emergency brakes are fully released. When only tires on one wheel-end are brake skidded, it is most likely due to mechanical issues such as brake component failure, improper maintenance of wheel-end brake components, improper installation of brake system components, and/or shoes frozen to the drum.

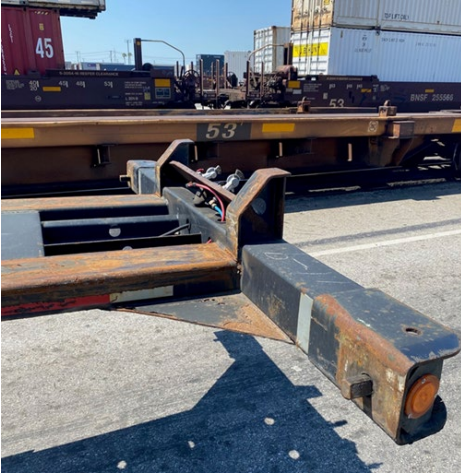
Chassis trackside with front pins engaged

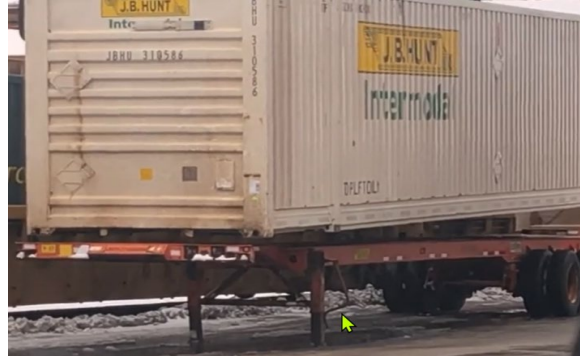
1. Container angled down on chassis

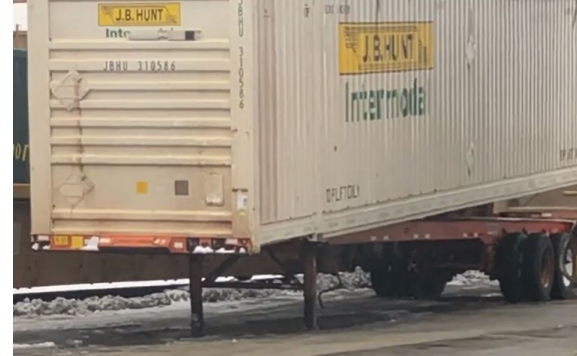
2. Container forced down and slid until impact with front bolster *

* Damage occurs to front pins, bolster and landing gear

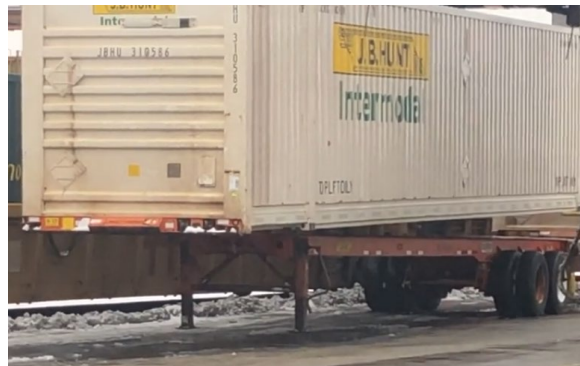
3. Chassis lifted to confirm securement

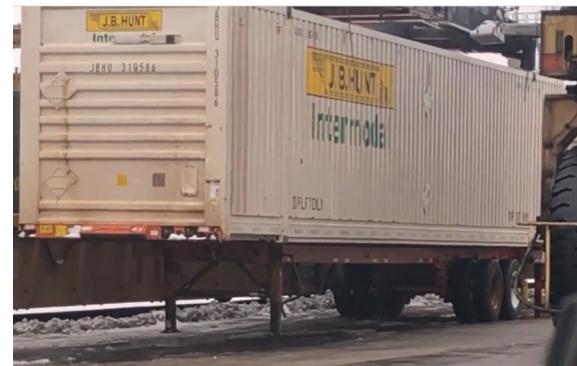
4. Rear of container placed on chassis and then front of chassis placed to ground **

** Additional damage occurs to the landing gear

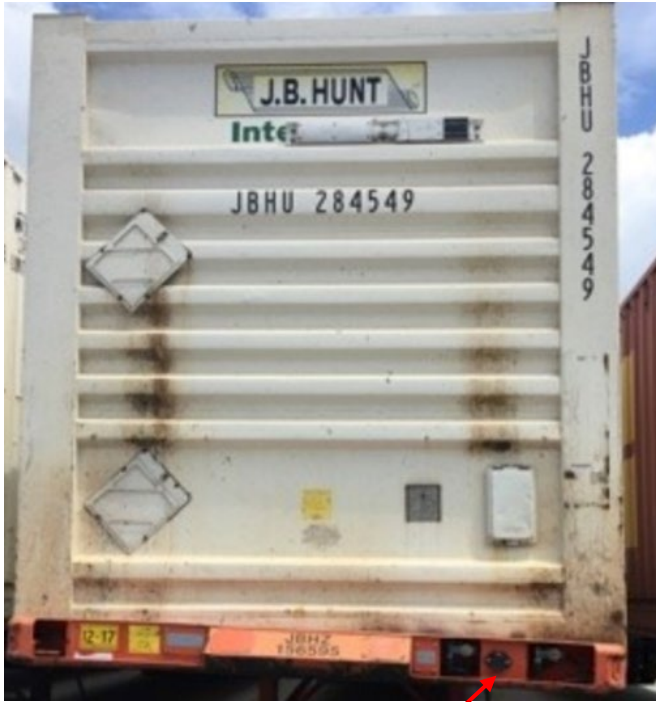
Container mounted on pin

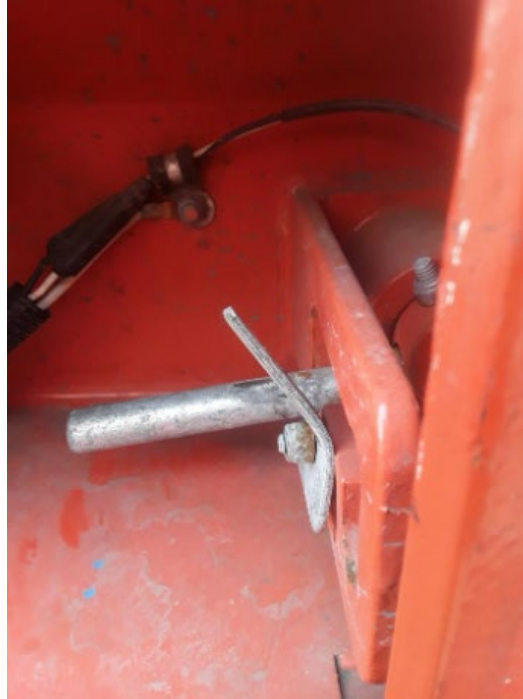
Bent or broken pin securement

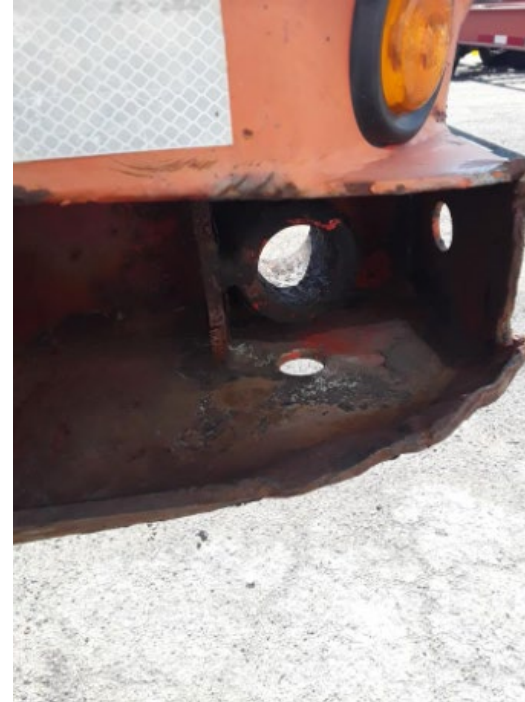
Broken/missing pin and housing

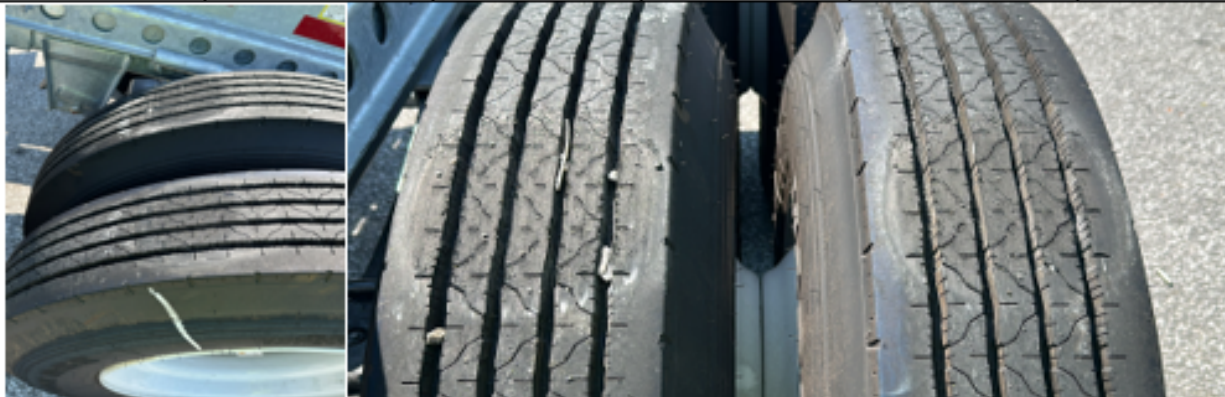
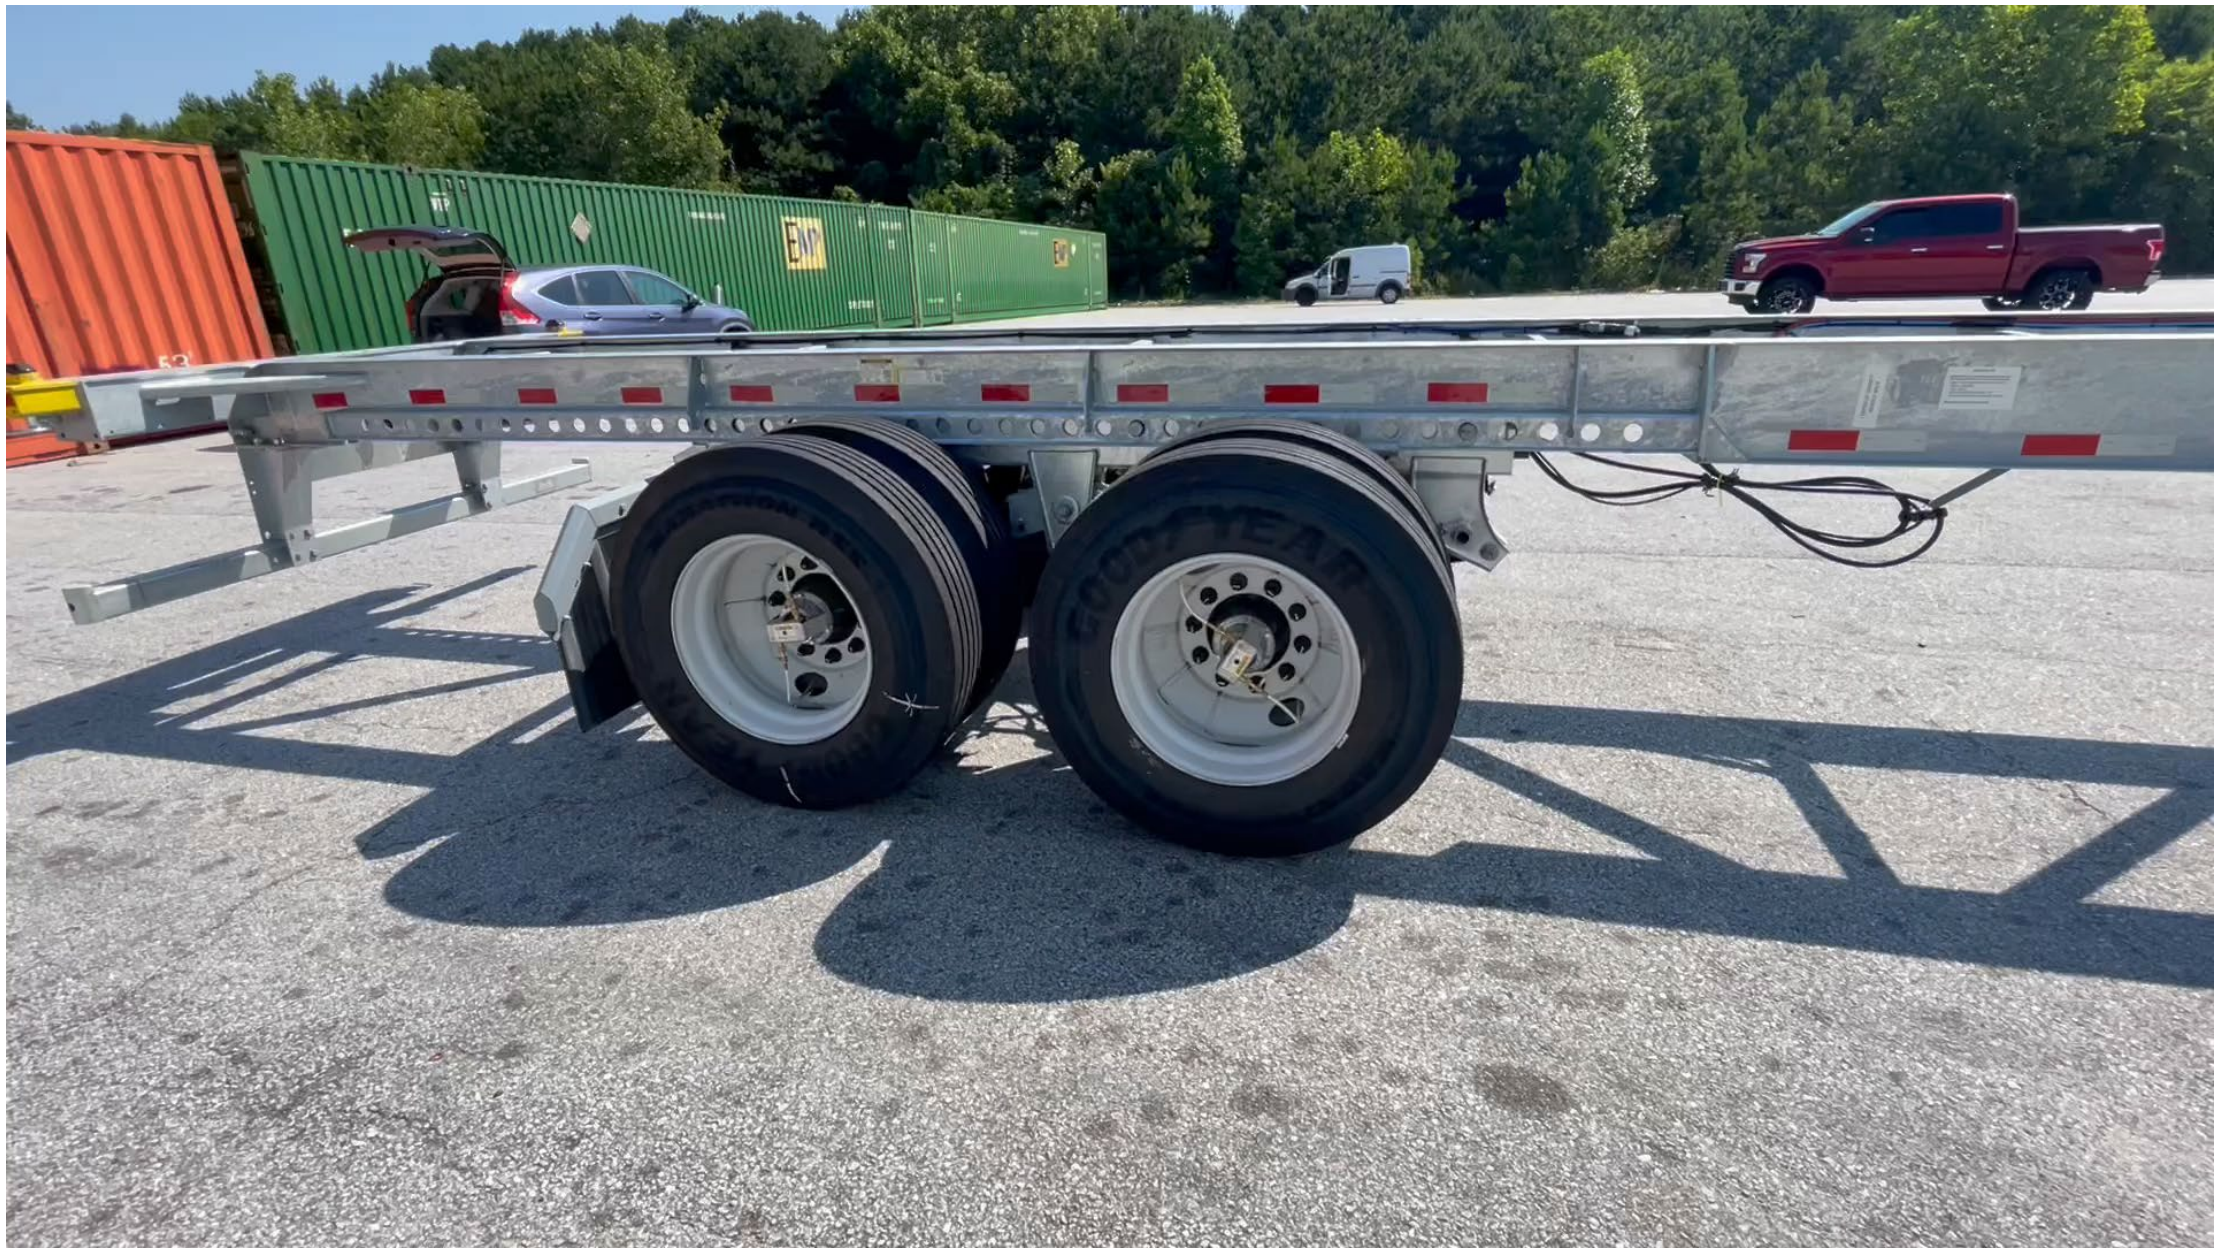
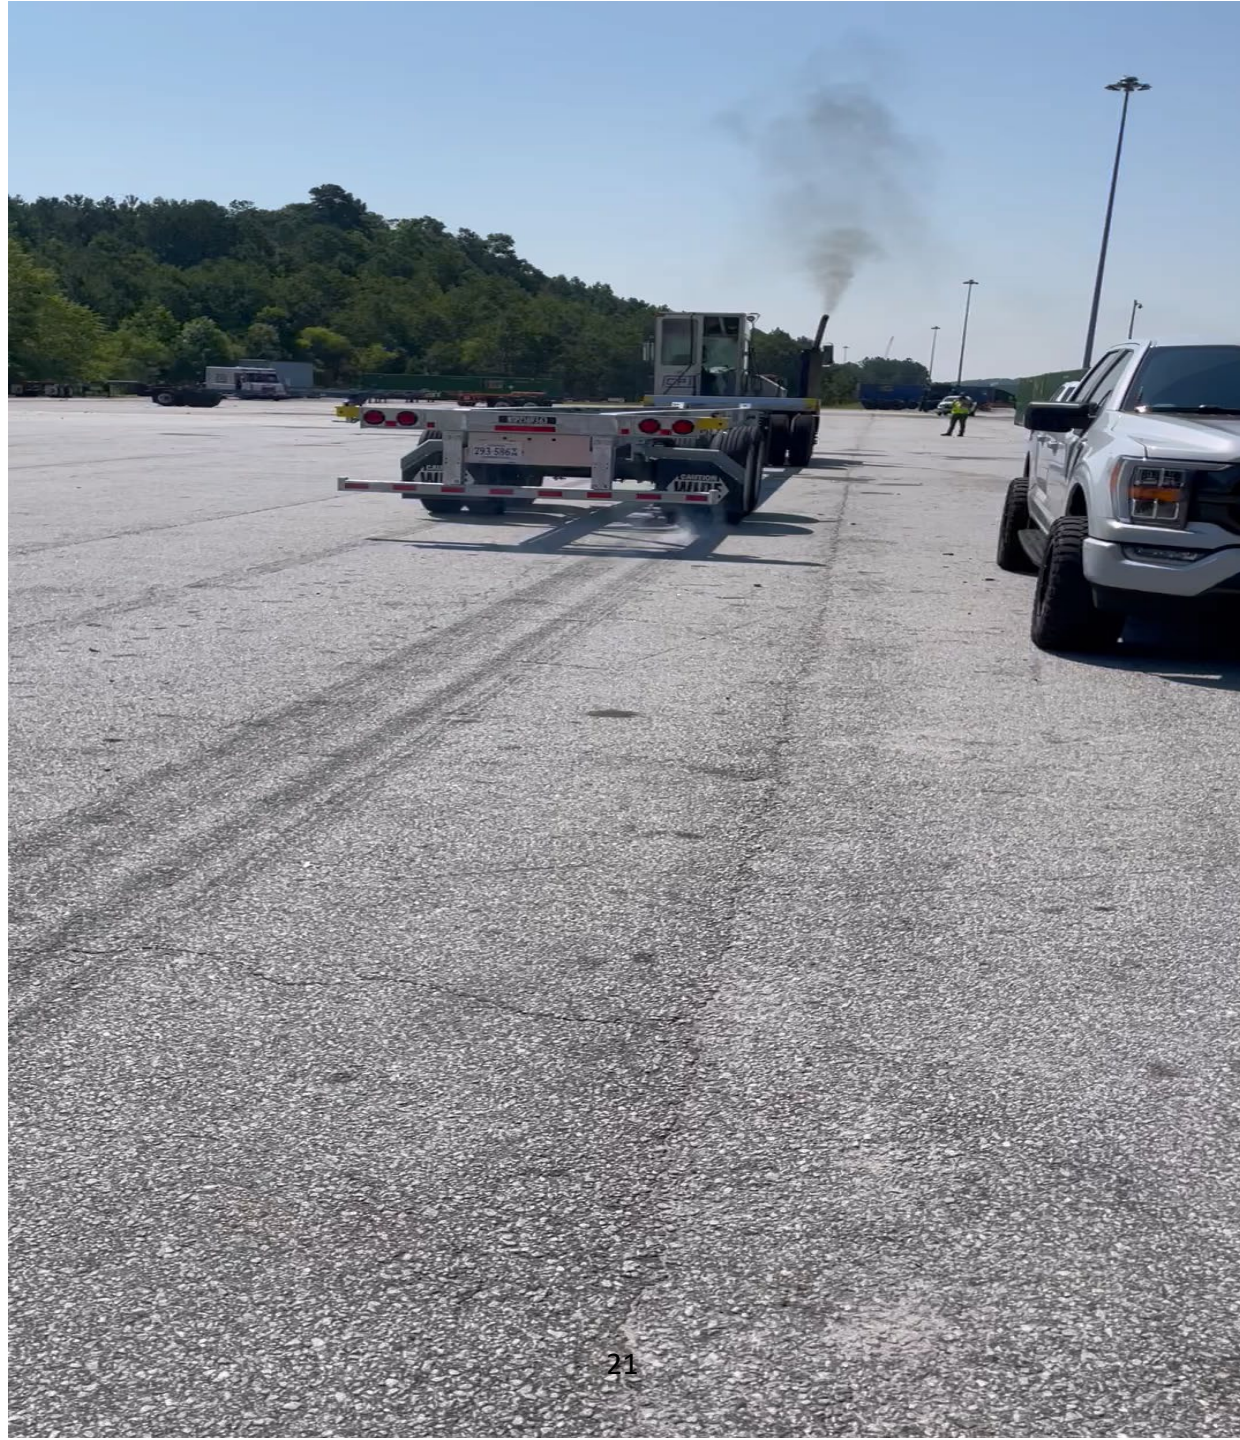
Situation 1: Bare chassis with locked brakes (estimated 7,8400 lbs.)

Tire location	Distance	Starting tread depth	End tread depth	Tire location	Distance	Starting tread depth	End tread depth
ROF	15	15/32	15/32	RIF	15	8/32	8/32
ROF	50	15/32	15/32	RIF	50	8/32	8/32
ROF	100	15/32	14/32	RIF	100	8/32	8/32
ROF	200	15/32	14/32	RIF	200	8/32	7/32

Tire location	Distance	Starting tread depth	End tread depth	Tire location	Distance	Starting tread depth	End tread depth
ROR	200	16/32	14/32	RIR	100	16/32	13/32
ROR	300	16/32	13/32	RIR	200	16/32	12/32

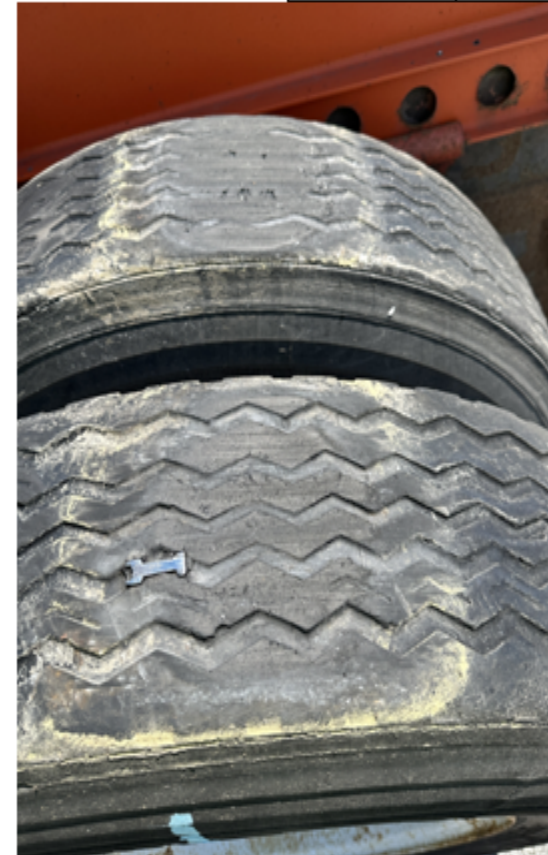
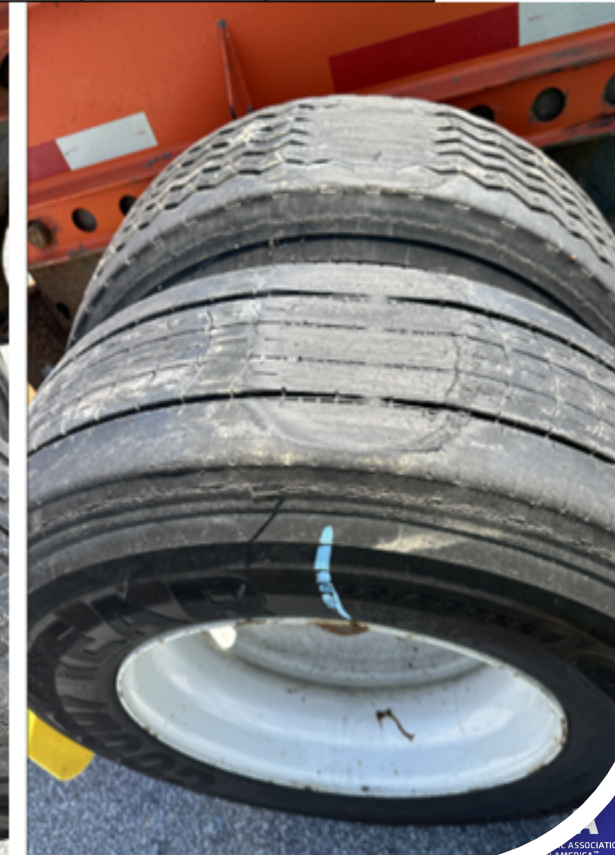
Random 600' post drag observation

Tire location	Distance	Starting tread depth	End tread depth
LOF	600	6/32	3/32
LIF	600	10/32	3/32
LOR	600	6/32	3/32
LIR	600	10/32	3/32
ROR	600	9/32	0/32
RIR	600	8/32	0/32
ROF	600	5/32	0/32
RIF	600	4/32	0/32

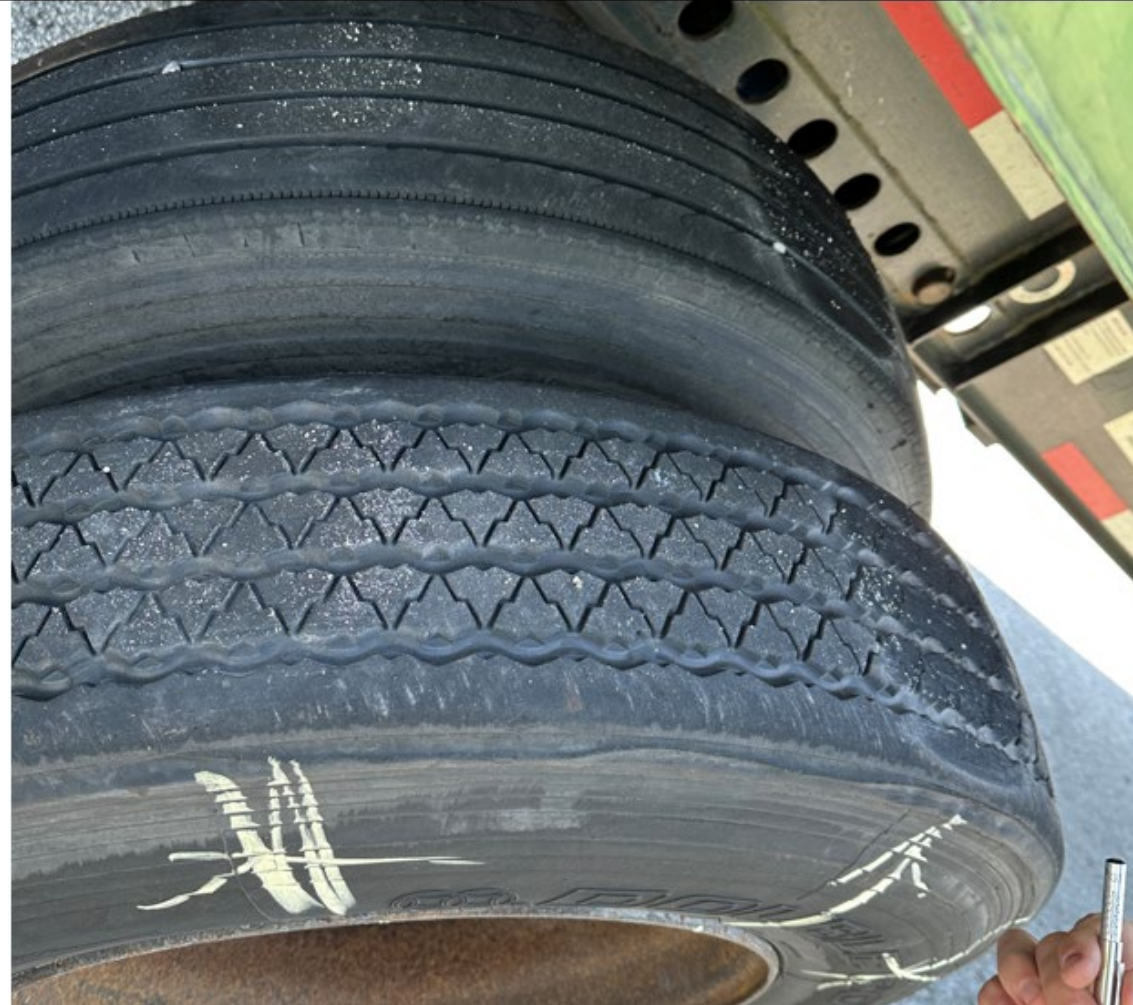
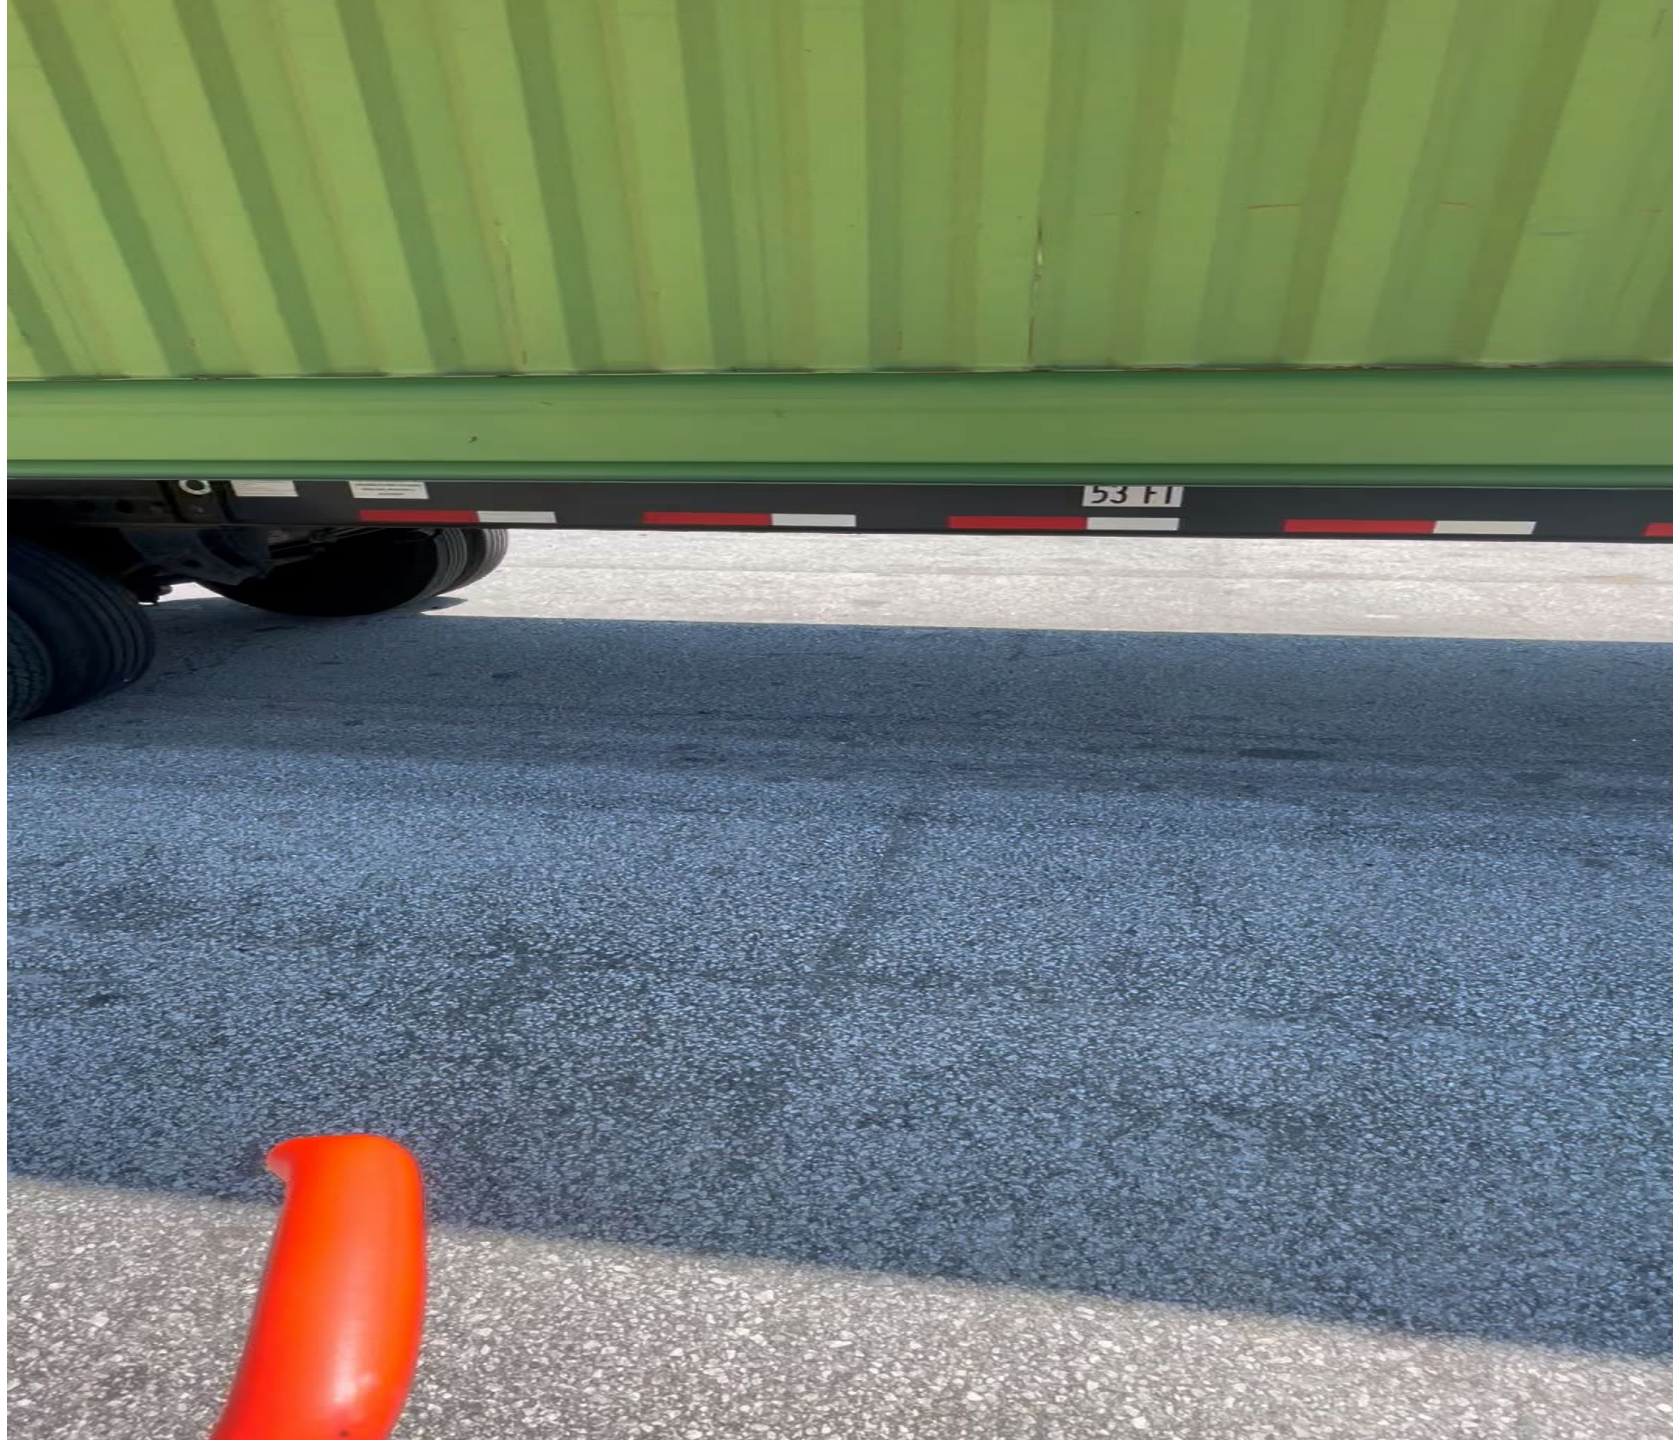
Situation 2: Mated chassis with an empty steel container with locked brakes (estimated 17,800 lbs)

Tire location	Distance	Starting tread depth	End tread depth	Tire location	Distance	Starting tread depth	End tread depth
ROF	50	10/32	9/32	RIF	50	10/32	9/32
ROF	100	10/32	8/32	RIF	100	10/32	8/32
ROF	200	10/32	7/32	RIF	200	10/32	7/32

- A chassis mated with an empty container will skid flat a tire at a faster rate than a bare chassis
 - Loaded containers, especially heavy loads, are less likely or not likely to skid flat, maybe wear out brakes faster than other scenarios.
- The amount of observations does not allow the team to claim any statistical significance to these observations
- These findings are simply what the team observed during this limited experiment
- We challenge other IEPS to replicate the experiment
